Name of Dam: Lake Devolia Dam

PHASE I INSPECTION REPORT NATIONAL DAM SAFETY PROGRAM

Lake Devolia Dam (Inventory Number VA 03331),
Caroline County, Commonwealth of Virginia.

January 1981

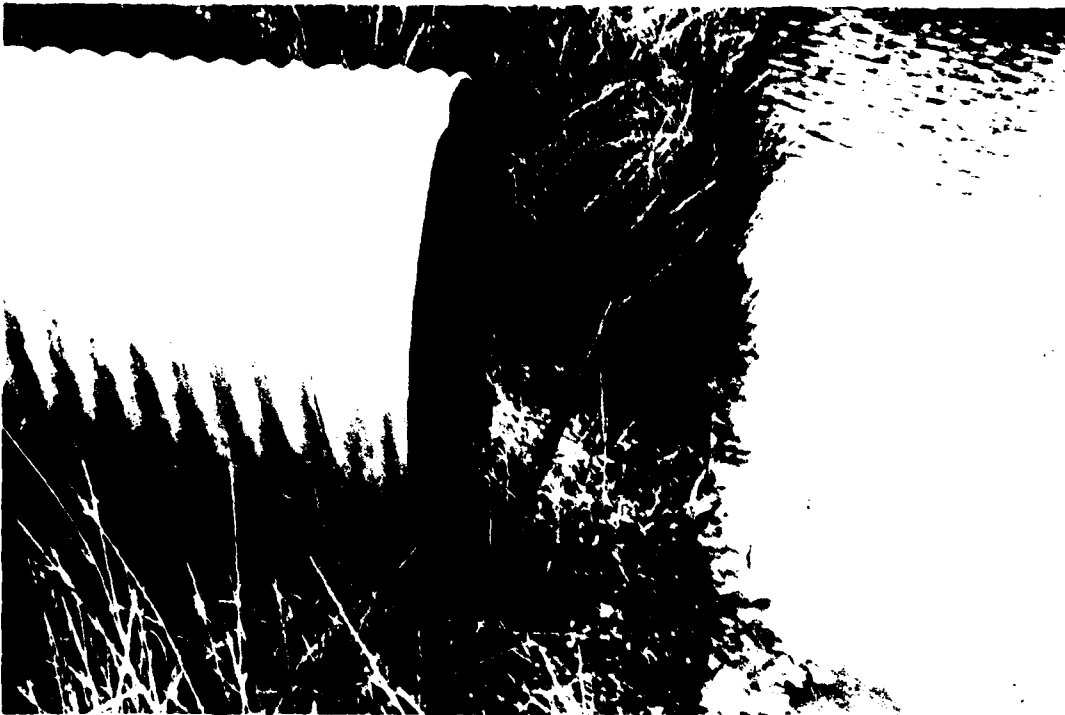
The 36-inch principal spillway was protected by a section of steel screen (3/4-inch mesh) held loosely against the lower half of the inlet with a steel stake (Photo 3). The screen was not clogged. The inlet area was not protected by riprap. The outlet area of the 36-inch principal spillway is protected by half-sections of 54-inch C.M.P. These half-sections do not extend all the way down the embankment (Photo 4). Discharges empty from the half-sections onto riprap just above the toe of the dam. The half-sections of 54-inch C.M.P. are not anchored. Some erosion, due to drainage from the crest, was observed around the top of the outlet pipe of the 36-inch principal spillway.

PHOTO 3. 36-inch Spillway Inlet, Steel Mesh Trash Screen

The partial screen at the inlet to the 36-inch principal spillway should be replaced with a full trash rack or screen to prevent obstruction of flow. The eroded area

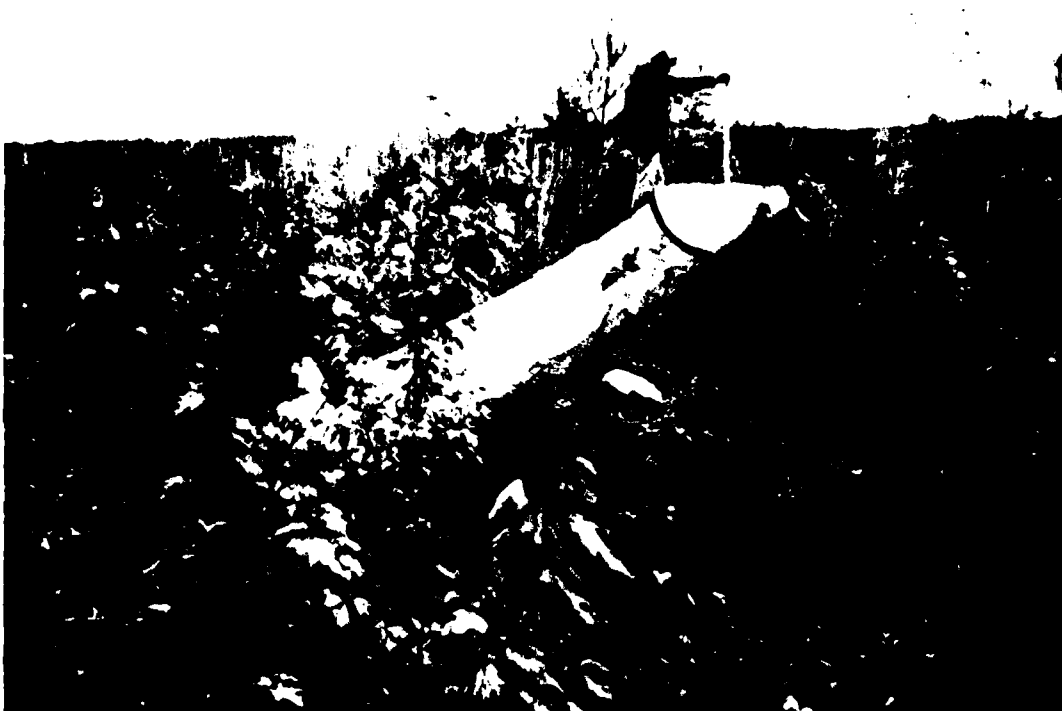
**PHOTO 4. 36-inch Spillway Outlet, Half Sections CMP Extending
Down Embankment**

- 6) Repair and riprap the eroded outlet area for the 24-inch principal spillway. Also, riprap around the outlet of the 36-inch spillway.
- 7) Fill in, compact and reseed the existing discharge channel for the 24-inch principal spillway and construct a new riprapped discharge channel away from the toe of the downstream embankment.
